# **STABILIZATION OF LAND SLOPES IN SOUTHEASTERN OHIO**

**G. O. SCHWAB**

**OHIO AGRICULTURAL RESEARCH AND DEVELOPMENT CENTER  
WOOSTER, OHIO**

**ON THE COVER:** Terrace failure at the Eastern Ohio Resource Development Center, May 1973.

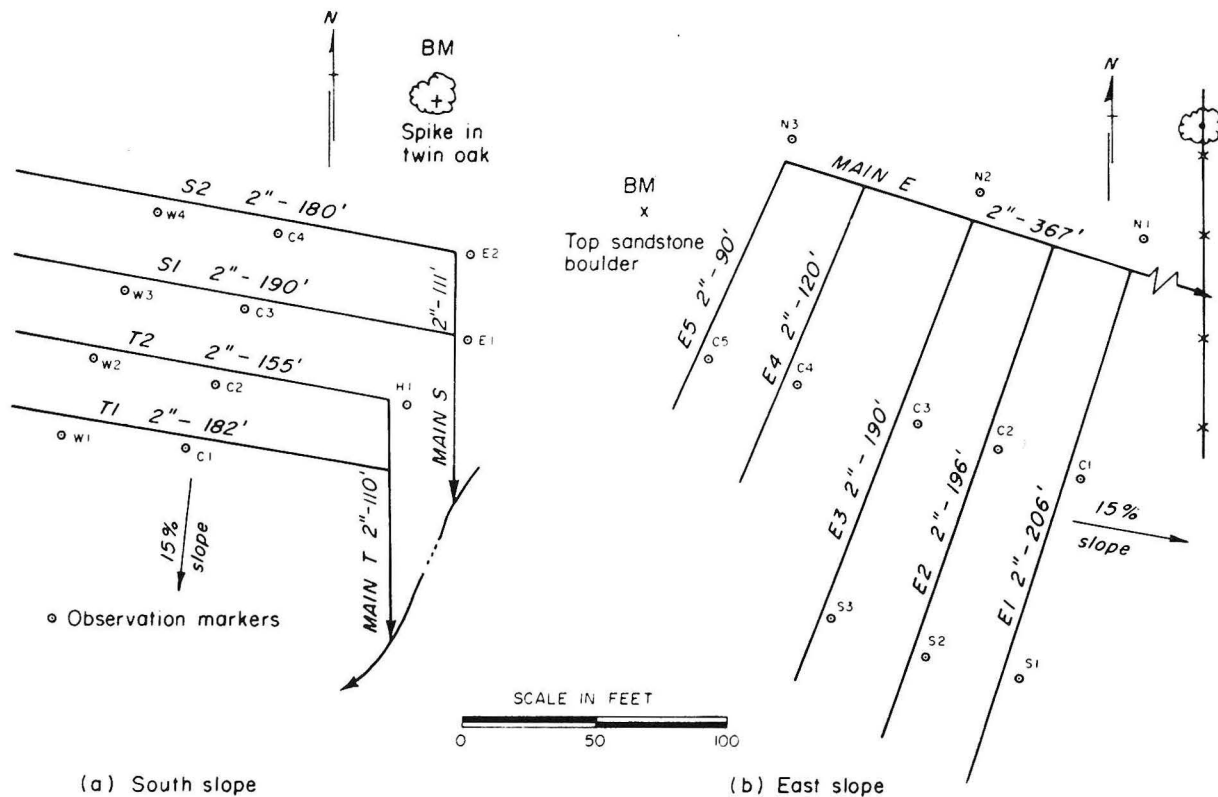
FIG. 2.—Layout of the (a) south slope and the (b) east slope drainage sites.

At the south site (Fig. 2a), the measurements shown in Table 1 indicate little if any significant movement. A small failure rim was evident before the drains were installed and 6 years later it was still there, but the slope appeared to be stabilized. The greatest misalignment of the vertical markers and horizontal movement was along the upper edge of the drained area. It was not possible to tell from the horizontal measurements which of two adjacent markers had moved. Movement less than 0.1 ft should be ignored as this is probably within the error of measurement. Elevation changes were 0.1 ft or less and these were also within the measurement error.

About 2100 feet of 2-inch diameter corrugated plastic drain tubing were installed on grades up to 6% at the two sites in the fall of 1972 (Fig. 2). Spacing between drains varied from about 20 to 45 feet. The drains were installed with a mole plow at a depth of about 2 feet on land slopes averaging 15% which showed evidence of active soil movement. Twenty-two observation markers, described in Fig. 3, were located near the drains as shown in Fig. 2. A 1 $\frac{7}{8}$ -inch diameter rigid probe was placed in the tubing prior to filling the hole with sand to assure a straight tube. Distances between markers and straightness of the tubing (probe measurements) were determined to detect relative soil movement. Elevation of the markers was taken every 1 or 2 years.

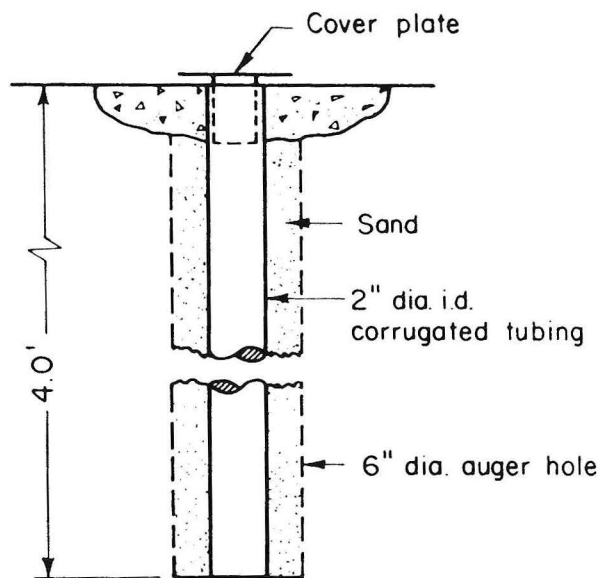
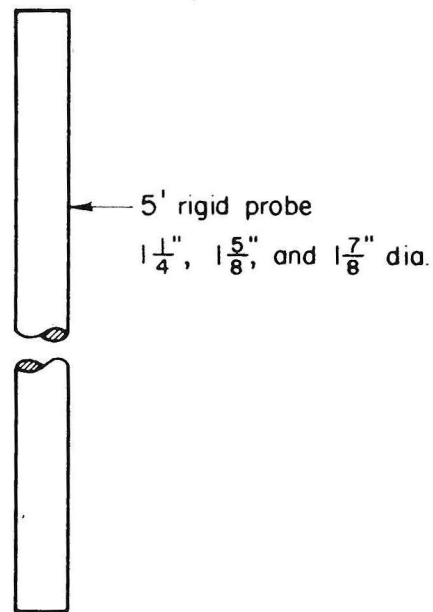
FIG. 3.—Detail of soil movement observation markers installed at sites (a) and (b).

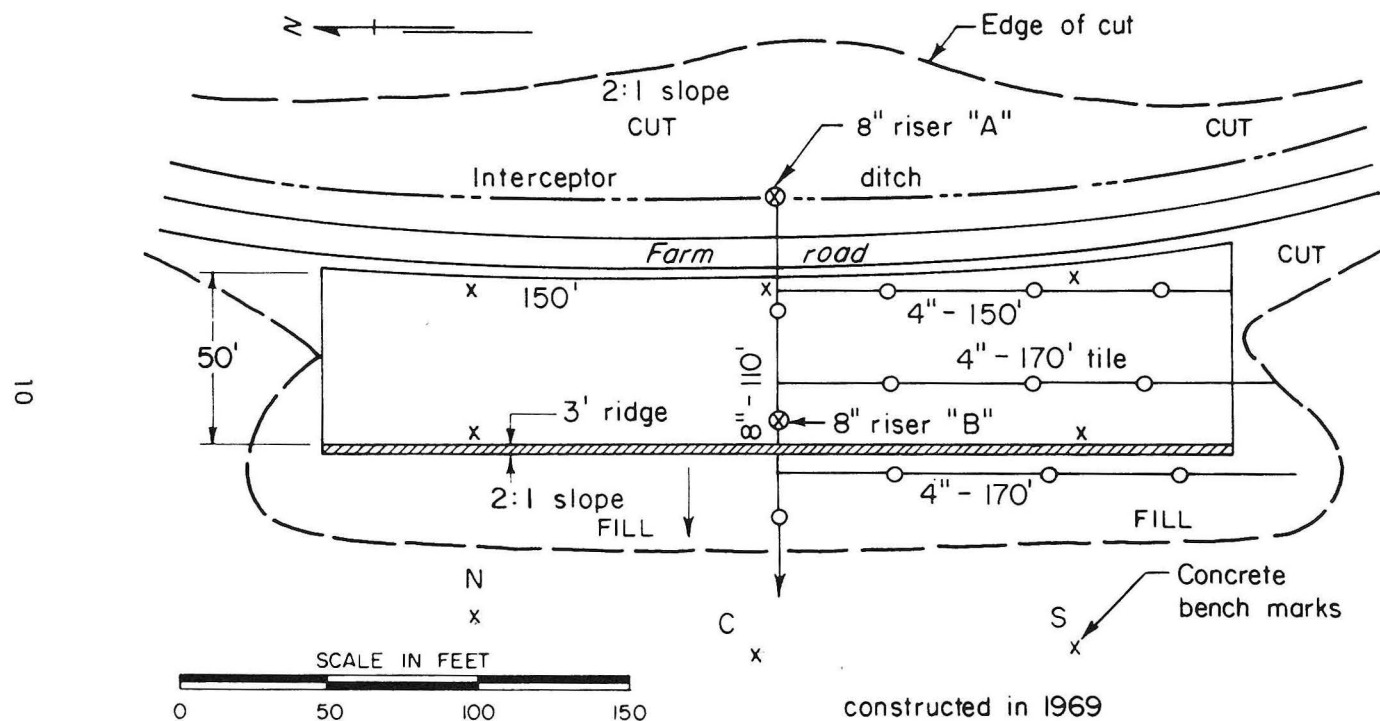
The bench terrace was constructed in the late fall of 1969 on an original slope of 19%. As shown in Figs. 4 and 5, pipe drains were installed in undisturbed soil at a spacing of 30 feet in the south half of the terrace. Horizontal distances between markers and elevations were recorded every 1 or 2 years to detect relative soil movement.

FIG. 4.—Plan view of bench terrace as built.

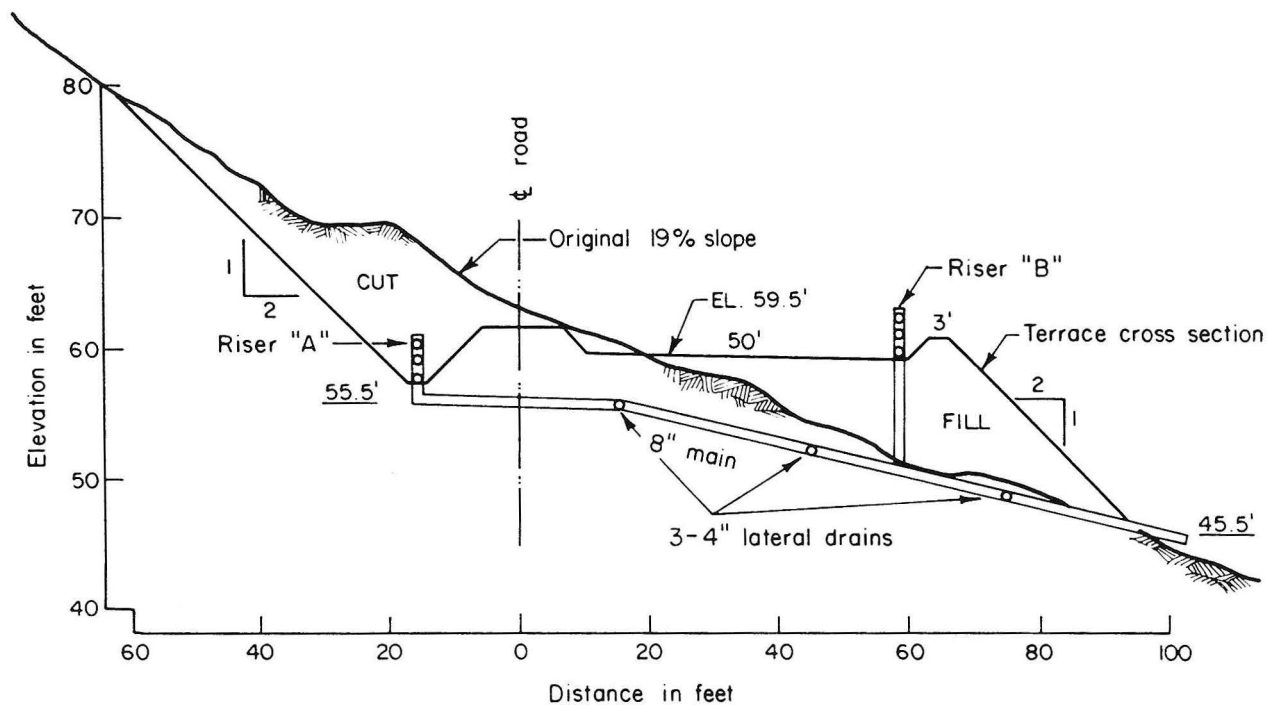
FIG. 5.—Cross section of bench terrace through center (C) section.
